BIG ROCHE A CRI LAKE LAKE CLASSIFICATION REPORT

**Presented by Reesa Evans, CLM, Lake Specialist
Adams County Land & Water Conservation Department
P.O. Box 289, Friendship, WI 53934**

NOVEMBER 2008

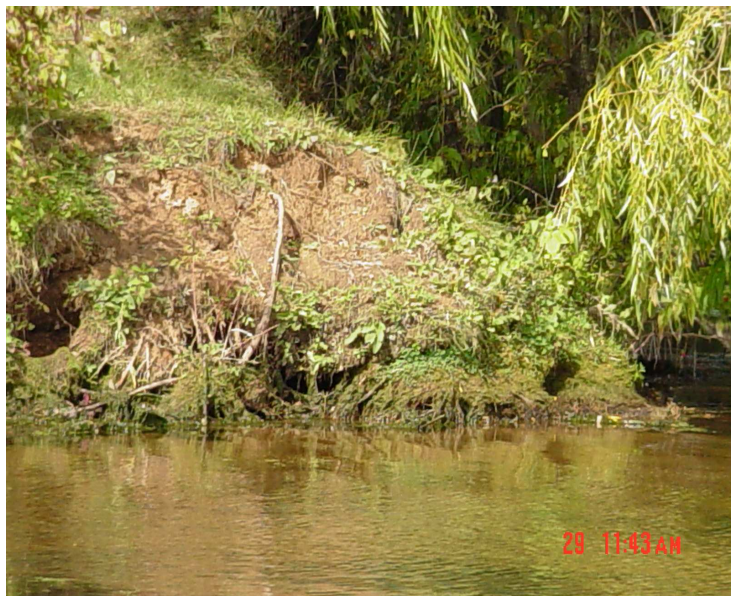
**Figure 10:
Example of Erosion
on Big Roche a Cri
Lake**

Big Roche a Cri Lake has a total shoreline 6.1 miles (32,208 feet). Much of the lakeshore is in residential use. Many of the areas near the shore are very sandy and steeply sloped. A 2004 shore survey revealed that 64% of Big Roche a Cri Lake's shoreline is vegetated. The rest of the shore is a mix of active erosion, sand, rock and/or other hard structure. Since the survey was done, Big Roche a Cri Lake District was awarded a lake management plan implementation grant that allowed several property owners to install shore protection practices to reduce some of the erosion. It has recently applied for an additional grant to address properties not previously covered.
